LIMITED FACILITY CONDITION ASSESSMENT REPORT

Kin Property #3397
416 Southbridge Street
Auburn, Massachusetts 01501

Blew Project # 24-6789.00
Report Date: September 25, 2024

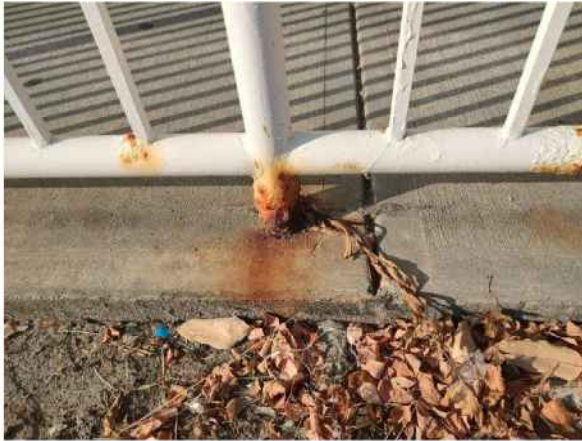
Blew observed rusted tubular metal railings. The railings should be sanded and painted. The railings need to be painted to prevent further damage to the metal and to prevent rust stains on the concrete flatwork. An opinion for these costs are included in the Tables.

Site - railing conditions

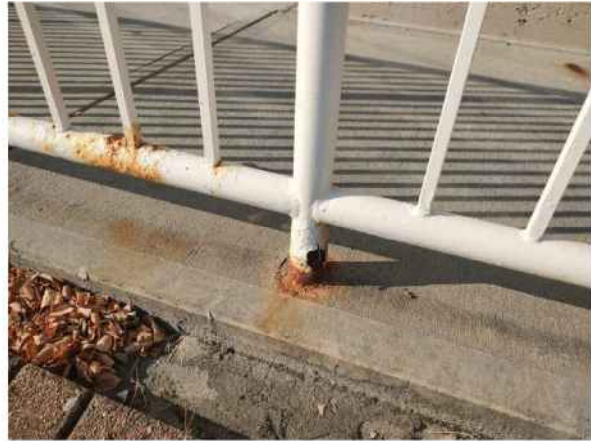
Site - railing at ramp condition

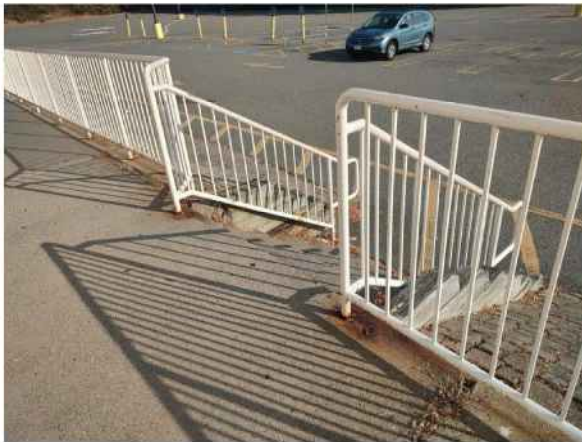
Site - railings

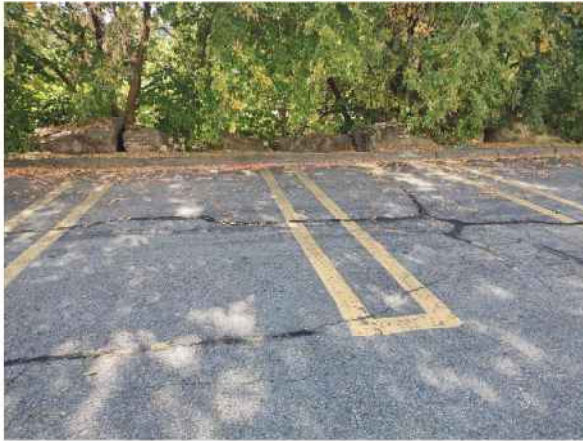
The asphalt pavement exhibited some localized alligating, cracks, and deterioration in several locations throughout the site. To prevent further deterioration and mitigate tripping hazards, these should be repaired. Budgets for this work are included in the Cost Schedule.

Site - asphalt condition

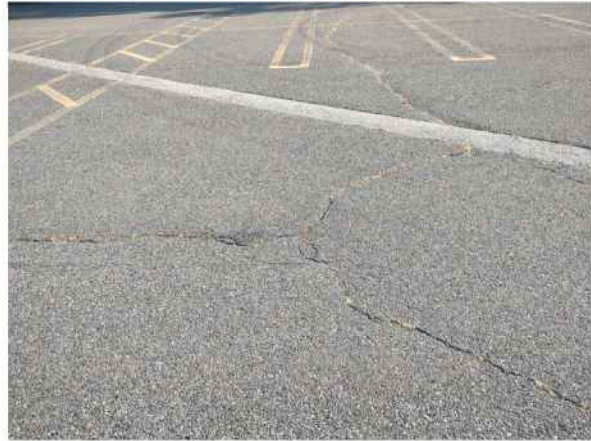
Site - asphalt cracking

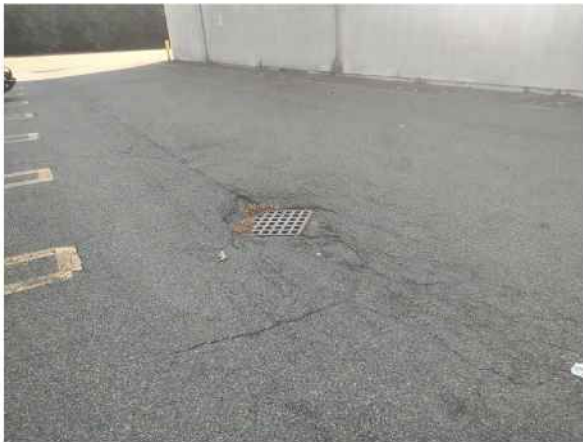
Site - condition at drainage grate

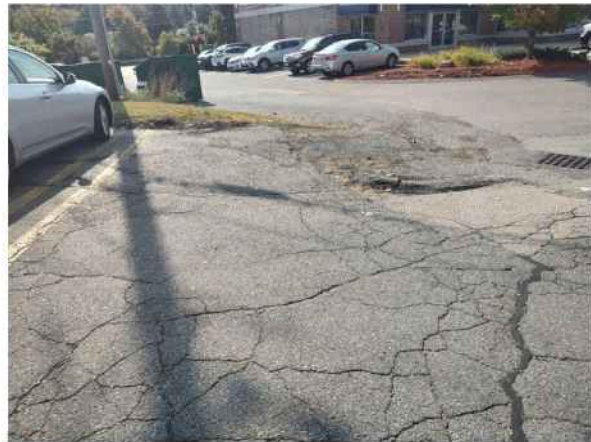
Site - map cracking

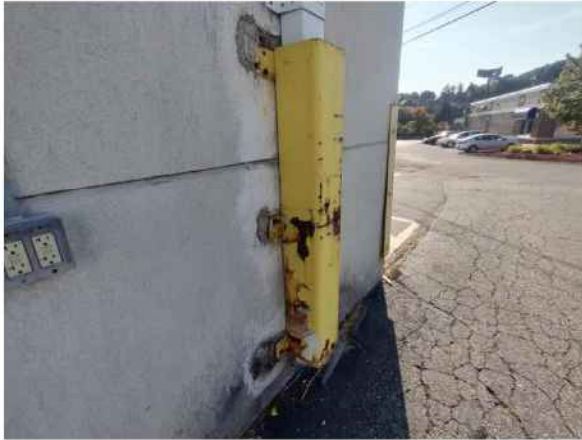
Site - asphalt condition and drainage

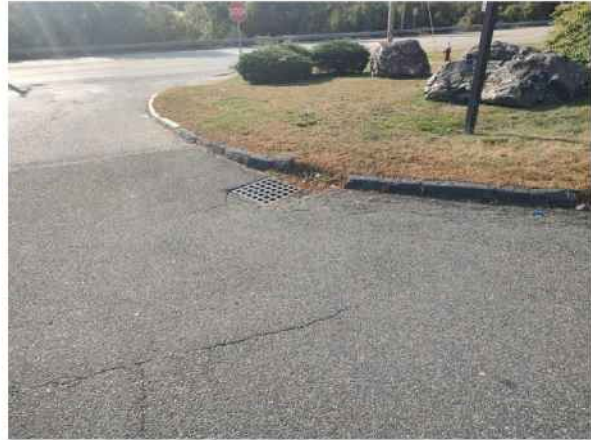
Site - curbing and asphalt

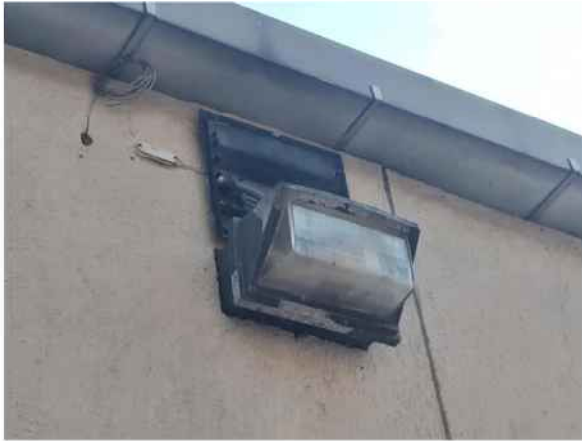
Item	Description	Action
Site Lighting	Site lighting consists of pole lights in the parking areas, and building-mounted lighting. One pole light is missing and replacement is advised. One wall pack on the west facade is dislocated from the mounting. Repair or replacement is advised.	IM

Site - lighting defect

Installation of a new pole light in the parking lot is advised. Repair or replacement of a wall pack is advised. An opinion of cost is provided in the Capital Expenditures table.

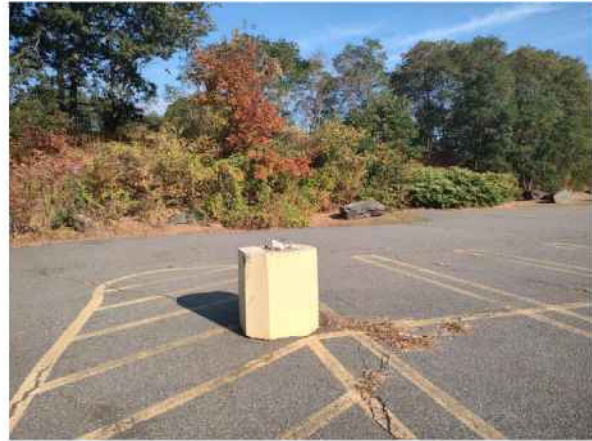
Site - missing site lighting

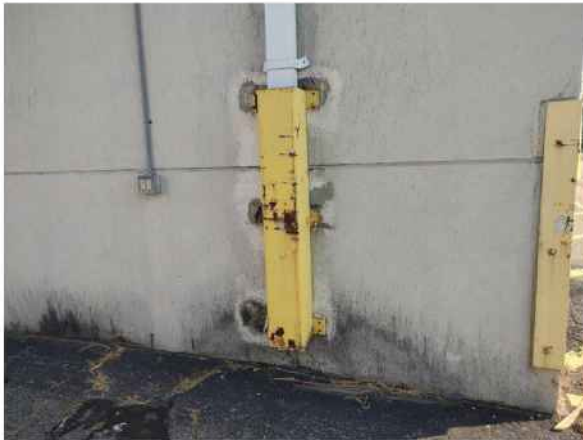
The EIFS facades are damaged at several locations adjacent to the loading docks and the approaching drive aisles. To prevent water infiltration, these areas should be repaired immediately. EIFS facades throughout are stained and dirty; painting the entire building after the repairs are completed is advised to present a uniform appearance of the exteriors.

Exterior - EIFS and metal condition

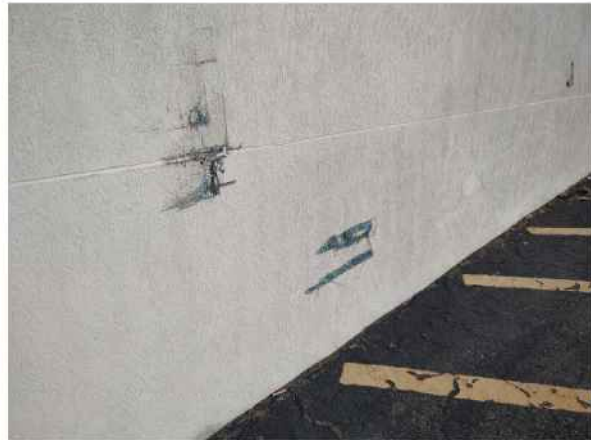
Exterior - EIFS condition

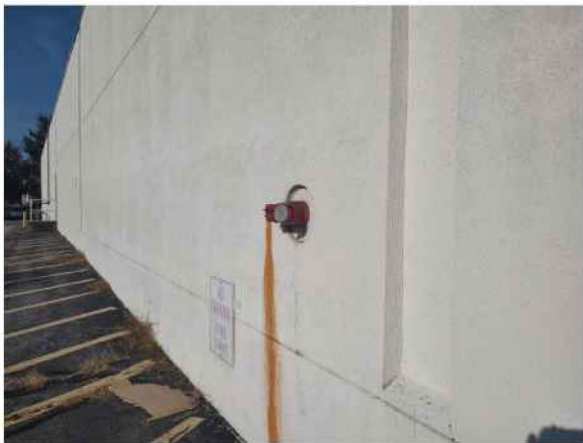
Exterior - EIFS staining at FD connection

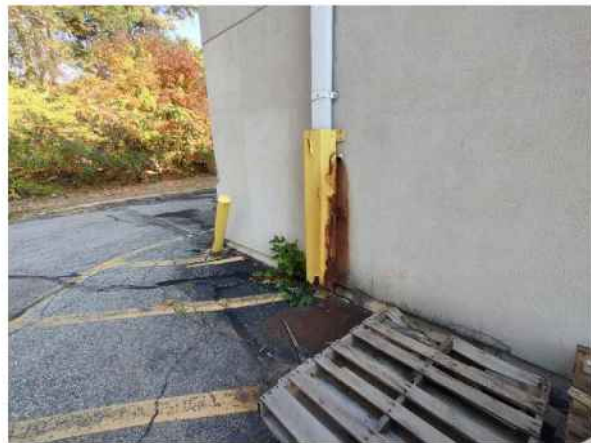
Exterior - facade condition

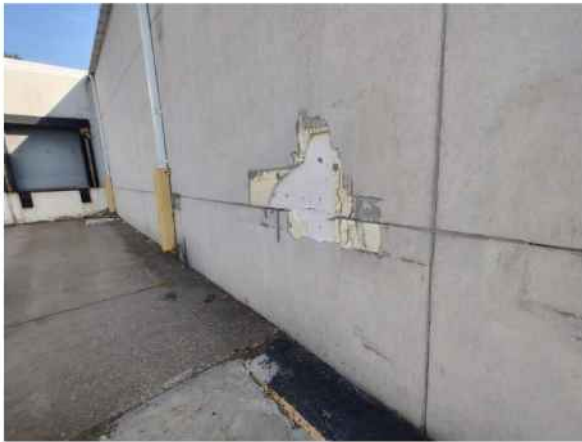
Facade - EIFS condition

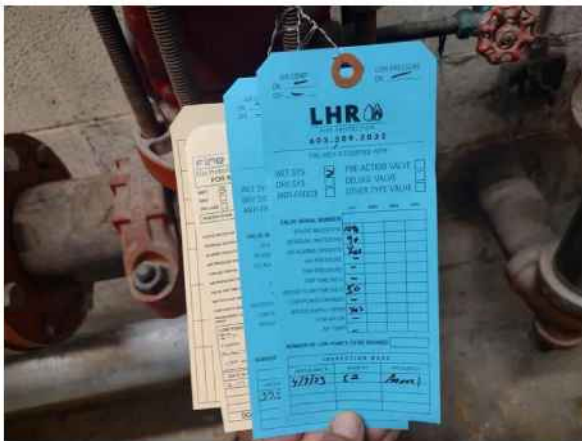
Item	Description	Action
Fire Sprinklers	The Property is 100% served by fire sprinklers.	RM
Fire Sprinkler Inspection	The most recent fire sprinkler inspection is dated April 7, 2023, by LHR Fire Protection	IM
Type of Sprinkler head	No recalled fire sprinkler heads, by Omega, Central, CSC, Central or Star, were observed.	NA

FLS - current sprinkler status (expired)

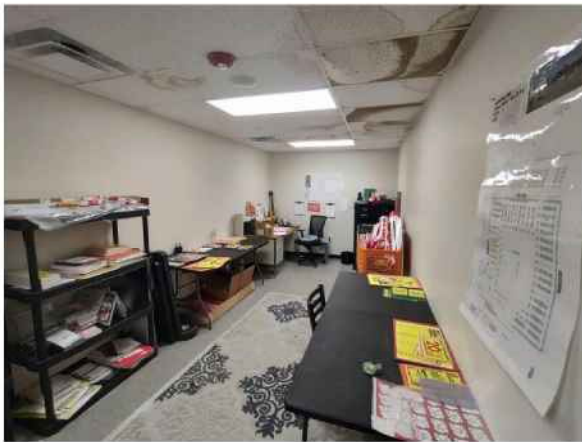
Interior - office area

Replace the stained ceiling tiles in the rear office area.

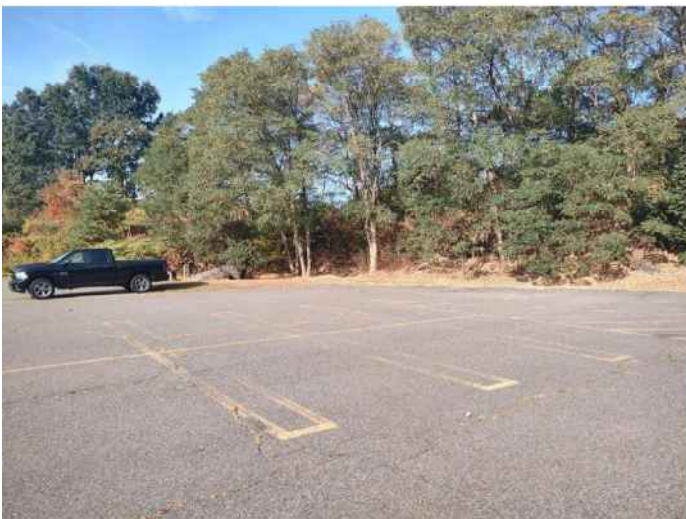
#3 Site - asphalt condition

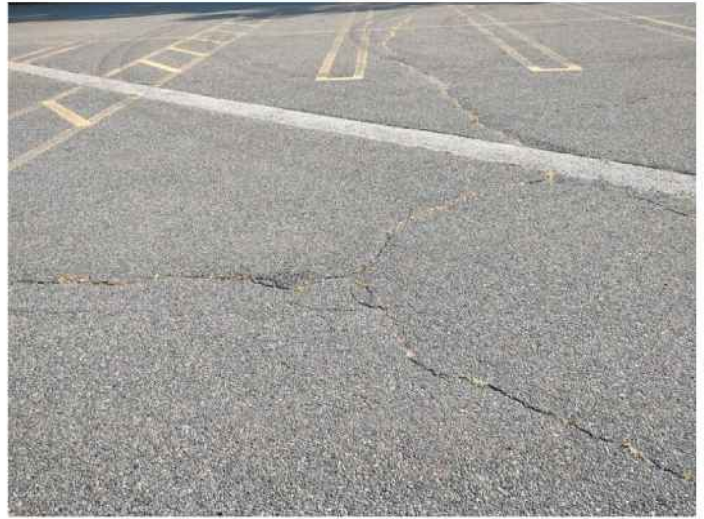
#6 Site - asphalt cracking

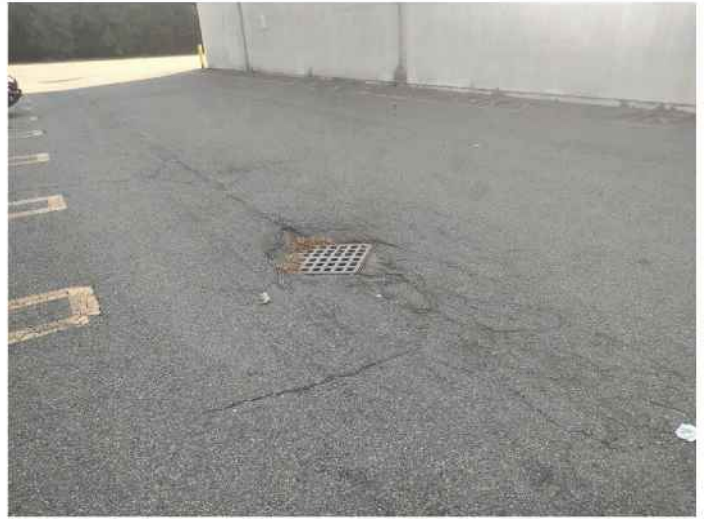
#10 Site - condition at drainage grate

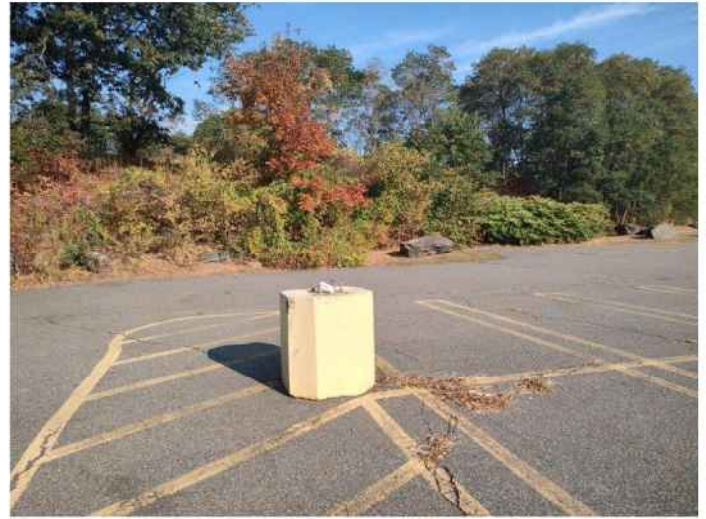
#18 Site - missing site lighting

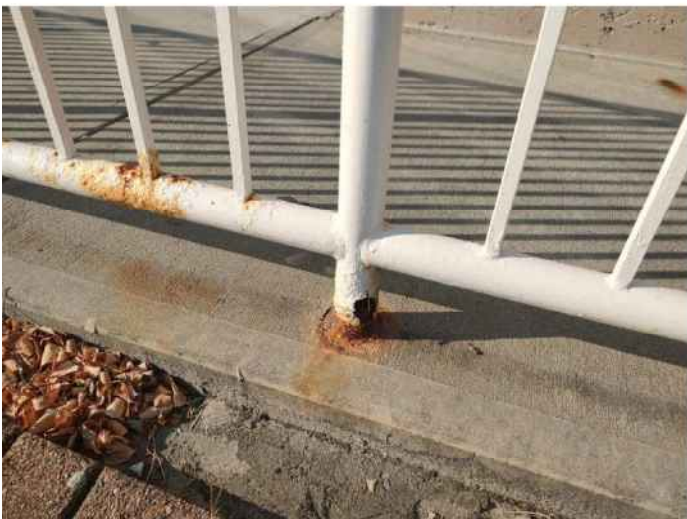
#23 Site - railing at ramp condition

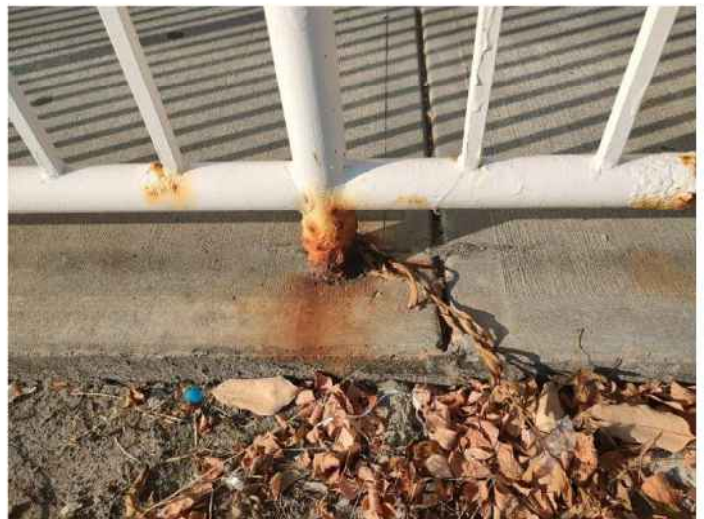
#24 Site - railing conditions

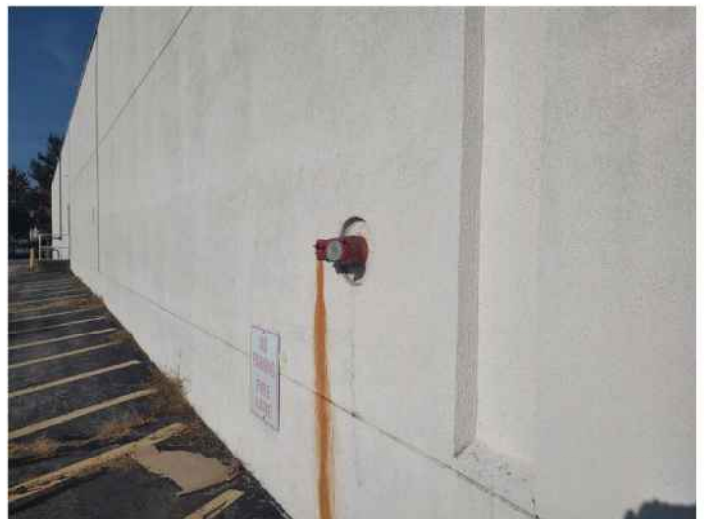
#40 Exterior - EIFS staining at FD connection
